September 18, 2020

Re: 3-Year AHERA Reinspection  
RPF File No.: 209999

RPF Environmental, Inc. (RPF) conducted an asbestos reinspection for the Sunapee School District on August 28, 2020 with EPA Asbestos Hazard Emergency Response Act (AHERA) requirement. The reinspection included a visual inspection of the areas known to contain asbestos-containing building materials (ACBM) and assumed ACBM, as stated in the AHERA inspection records provided to RPF for review.

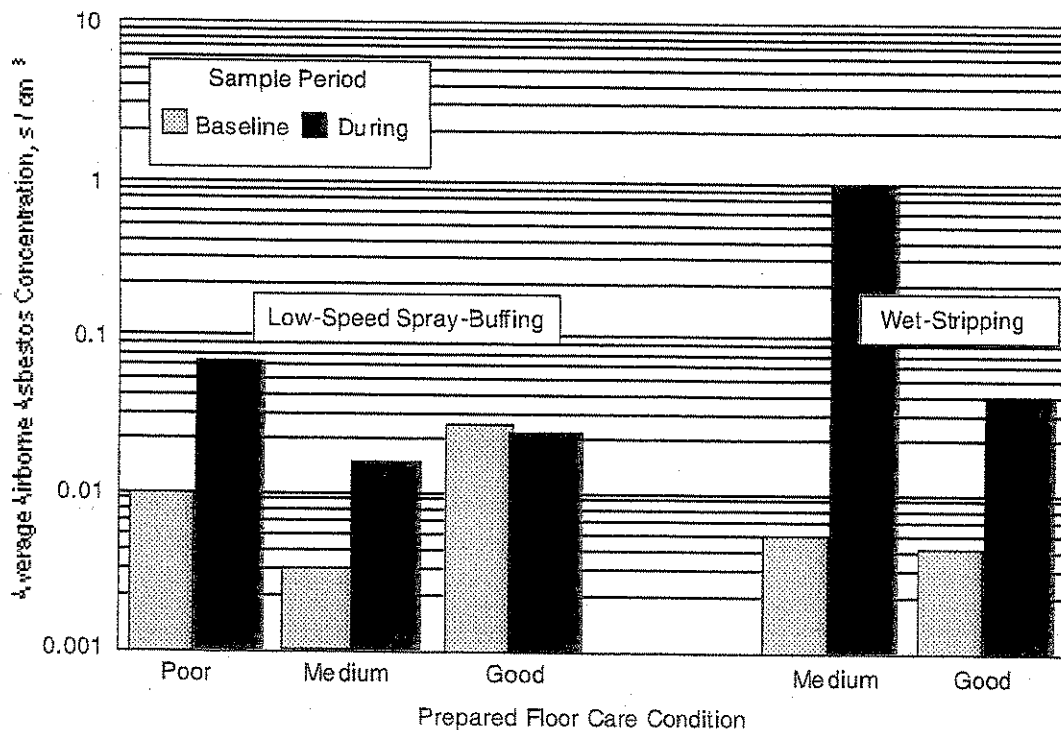
Figure 1. Average airborne asbestos concentrations during low-speed spraying of floors in prepared conditions.

Figure 1 illustrates the overall average (geometric mean) concentrations measured before and during low-speed spray-buffing and wet-stripping on floors in prepared floor conditions. Although the mean relative increase in airborne asbestos concentrations during low-speed spray-buffing tended to decrease as the floor care condition improved (i.e., poor condition resulted in a larger relative increase than medium, and medium condition showed a larger relative increase than good), the differences between the three levels of floor care were not statistically significant ( $p=0.1149$ ). Overall, the average airborne asbestos concentration during low-speed spray-buffing was approximately 2.6 times higher than the average baseline concentration. This increase was statistically significant ( $p=0.0017$ ). A 95% confidence interval for the mean airborne asbestos concentration during spray-buffing as a proportion of the baseline concentration showed that the overall mean airborne asbestos con-
